TECHNICAL REPORT GL-90-16

# INVESTIGATIONS OF MAGNETIC FIELD DISTURBANCES AT LITTLE ROCK AIR FORCE BASE COMPASS CALIBRATION HARDSTAND

Dwain K. Butler, Thomas B. Kean

September 1990  
Final Report

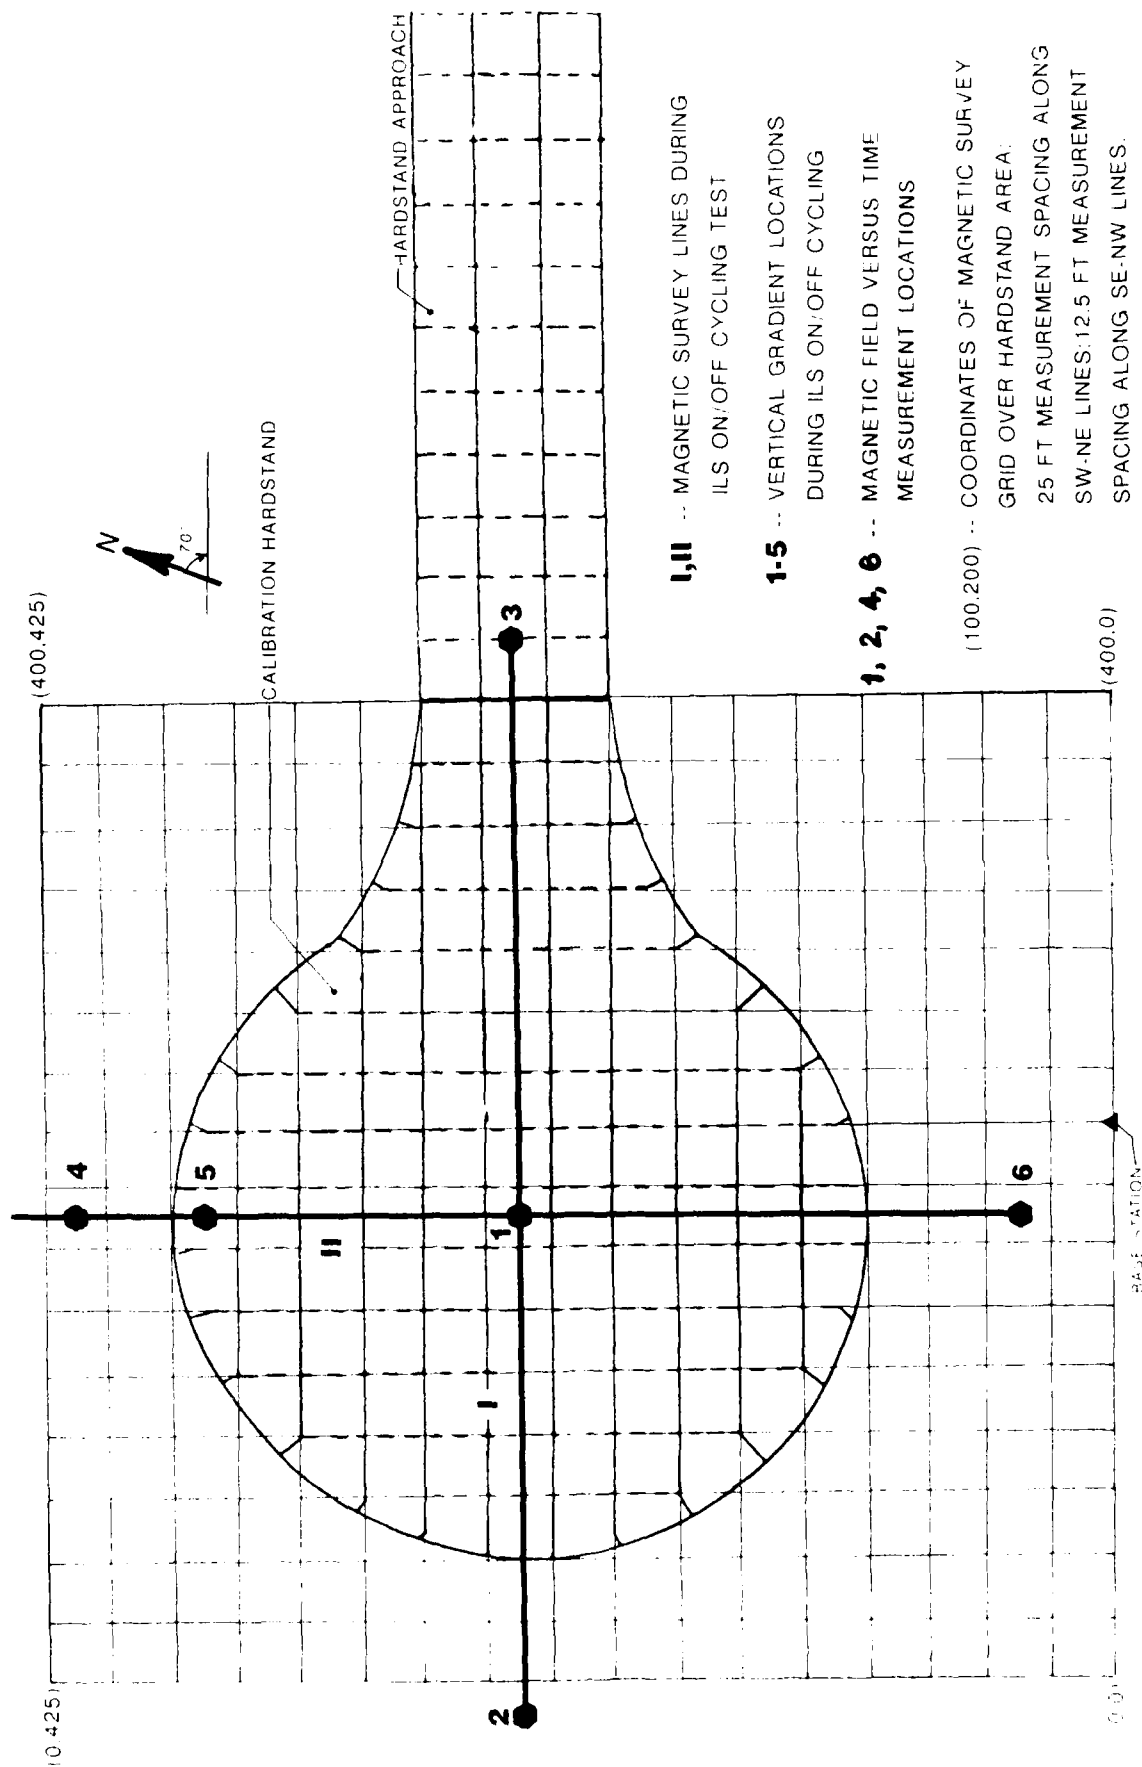
Figure 1. Survey layout at the LRAFB compass calibration hardstand

6. The layout of investigations to characterize the nature and source of magnetic disturbances at the calibration hardstand is illustrated in Figure 1. The 400 by 425 ft (122 by 130 m) gridded area was used for a survey of total magnetic field strength over the hardstand and immediate surrounding area. Measurement interval was 25 ft (7.6 m) along SW-NE lines, and 12.5 ft (3.8 m) along SE-NW lines, for a total of 595 measurements. Measurements were acquired with a digital proton precession magnetometer, which has an accuracy of 1 nT. Survey lines I and II were used to detect magnetic field effects in the hardstand area due to cycling the nearby ILS system (approach radar) on and off. Measurement interval along lines I and II was 12.5 ft. Locations 1-5 were used for magnetic vertical gradient measurements (variation of the magnetic field in the vertical direction) during the ILS on and off cycles. Locations 1, 2, 4, and 6 were used for magnetic field versus time measurements during ILS on and off cycles. Magnetic field versus time measurements were acquired with a recording proton precession magnetometer, which produces analog records on a strip chart recorder.

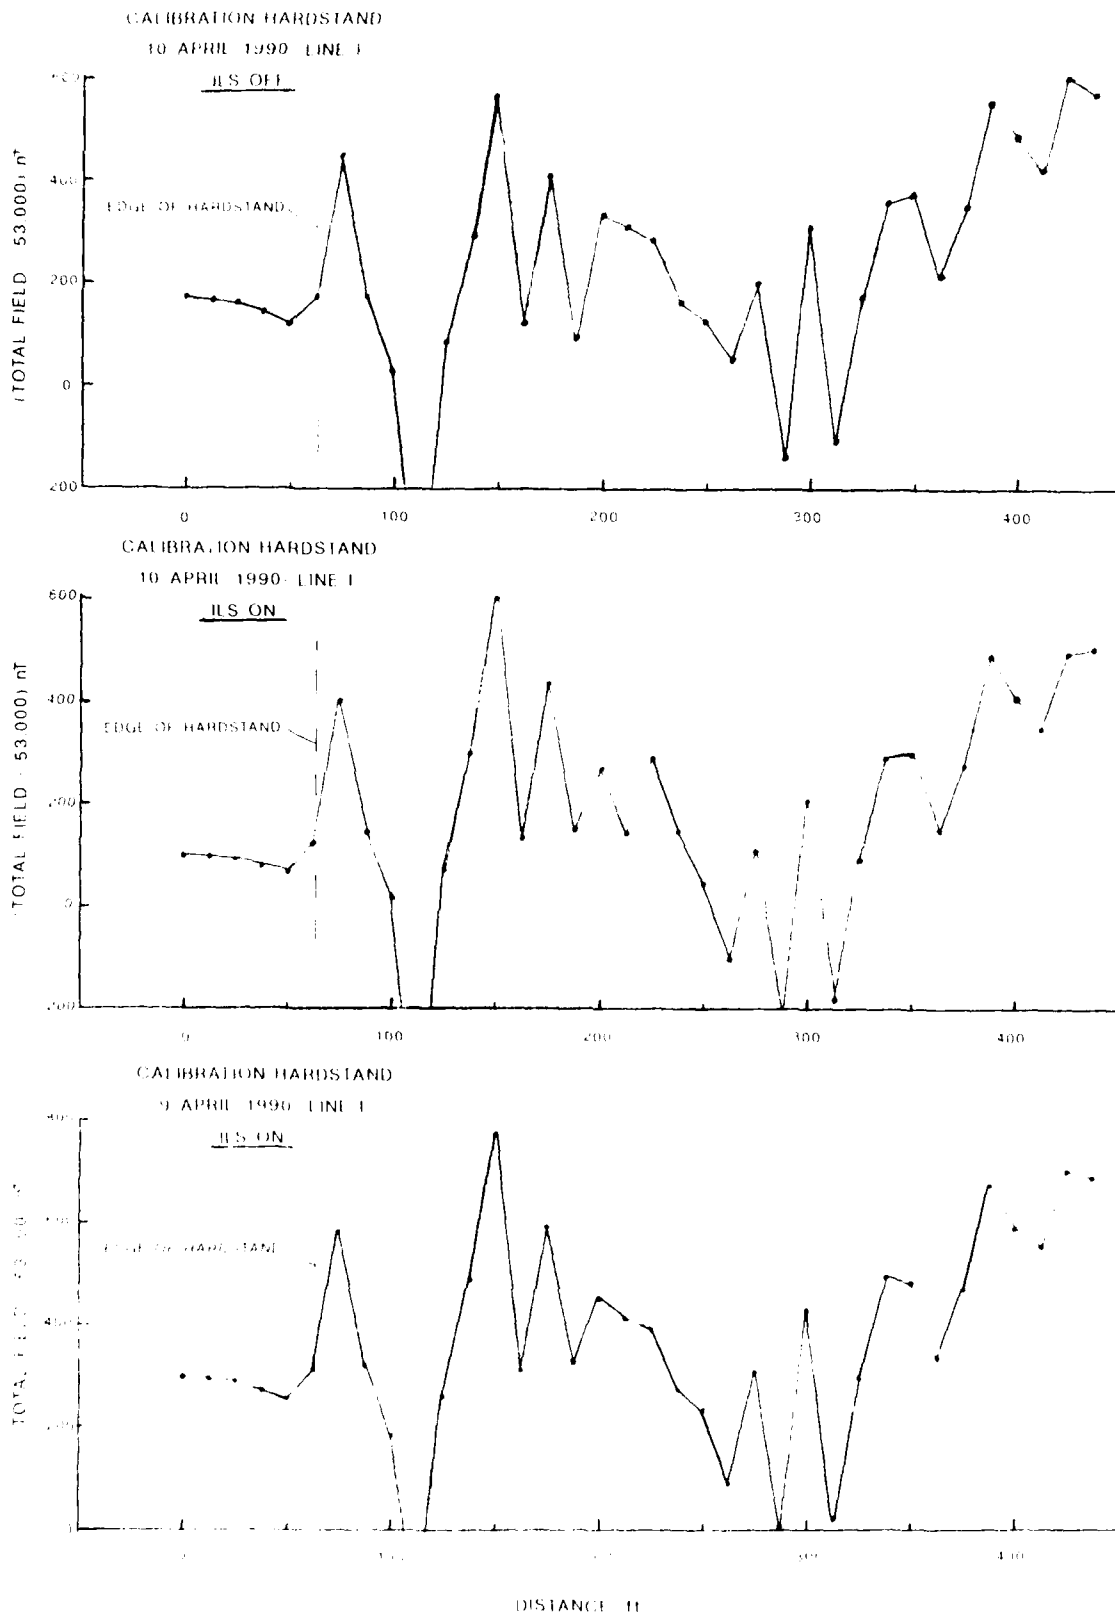
Figure 2. Magnetic field profiles along hardstand line I -- ILS on and off

8. Lines I and II. Results of magnetic field measurements along lines I and II (Figure 1) are shown in Figures 2 and 3. The bottom plot in both figures is for 9 April, with the ILS operating. The top two plots in both figures are for 10 April, during the ILS on and off cycling test. As noted in the PA (Appendix A), the most obvious observation is that the magnetic field strength varies extremely erratically along the lines. Variations of 600 nT or more occur between two measurement locations. Qualitatively, the measurements along the lines are very similar for both days of measurement and for both ILS on and off conditions. However, there are shifts in magnitude: (a) the average or baseline levels are shifted by 100-200 nT between 9 and 10 April and by 25-50 nT between the ILS on and off conditions; (b) magnitudes of some individual peaks or troughs relative to the surrounding magnitudes are shifted, with respect to different days and to ILS on and off conditions.

9. Two low magnetic anomalies are apparent in the line I results (defined by several data values). The first feature is a narrow low anomaly centered at approximately 110 ft of line I and has a half width at half maximum (hwhm) = 25 ft (7.6 m). A broad low magnetic anomaly is centered at approximately 300 ft of line I and has an hwhm = 100 ft (30.5 m). Significantly, the magnetic field strengths exhibit very small variations away from the hardstand and approach constant values, beyond 25 ft from the hardstand. However, the constant values away from the hardstand differ for the time and condition of measurement. This very subdued magnetic field expression off the hardstand was not observed in the PA, since all work was concentrated on the hardstand.

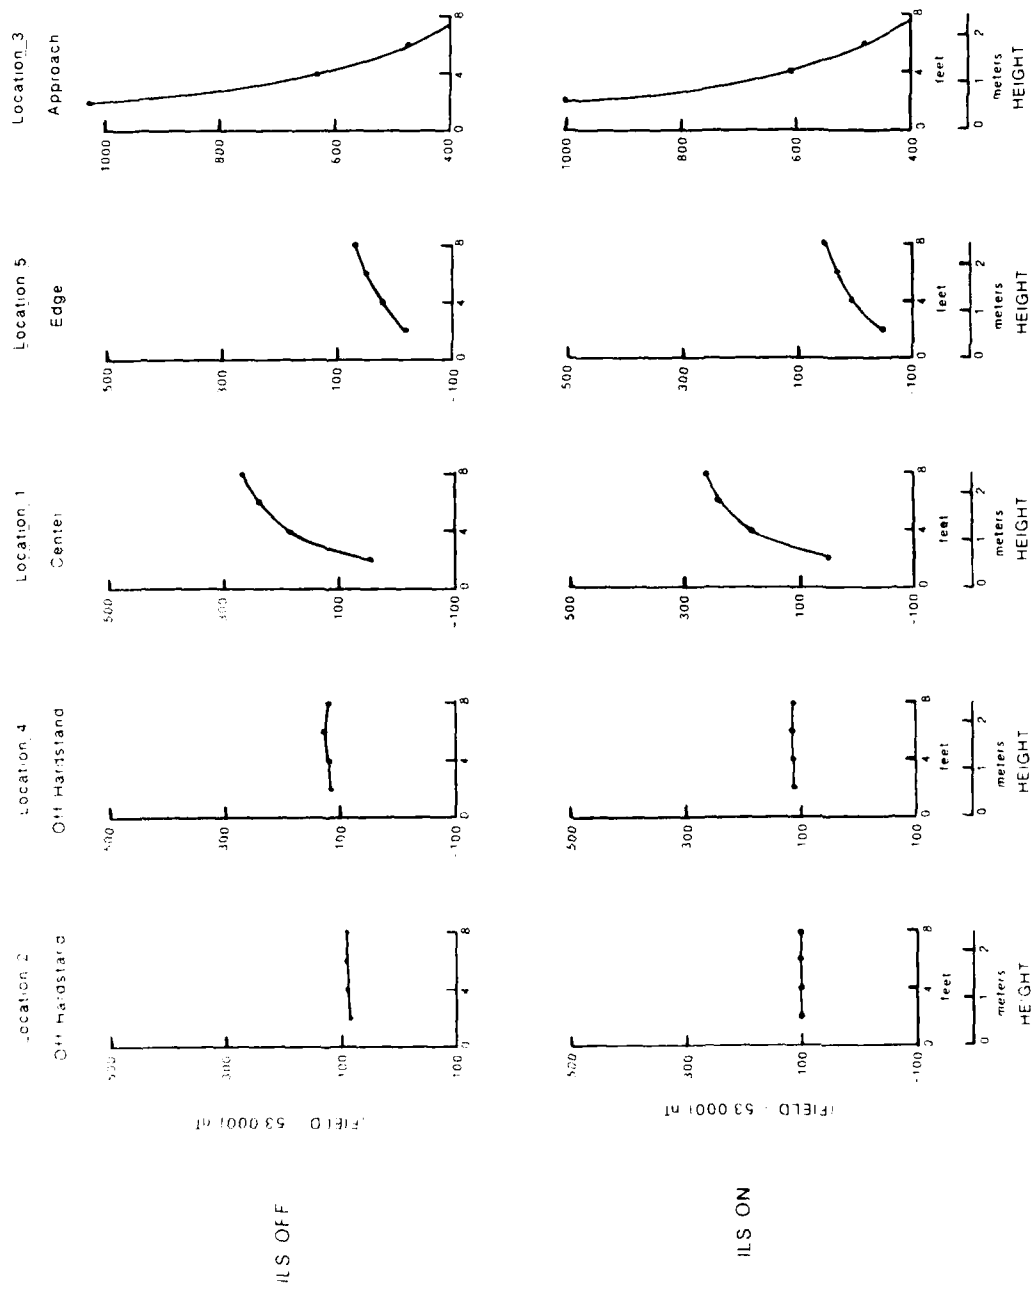
Figure 4. Vertical variations of the magnetic field on and off the hardstand -- ILS on and off

10. Vertical gradients. Measurements of magnetic field strength variations in the vertical direction are shown in Figure 4 for locations 1-5 and for ILS on and off conditions. Three distinct vertical magnetic gradient signatures are displayed. There is no detectable difference in the vertical magnetic gradient for the ILS on and off condition. Locations 2 and 4, off the hardstand, have nearly zero gradient. Locations 1

and 5, on the hardstand, have a large positive gradient; whereas, location 3, on the hardstand approach, has a very large negative gradient. These results are consistent with the magnetic profiles in Figures 2 and 3, in that the magnetic field on the hardstand is anomalous; whereas, the magnetic field off the hardstand is subdued and nearly constant.

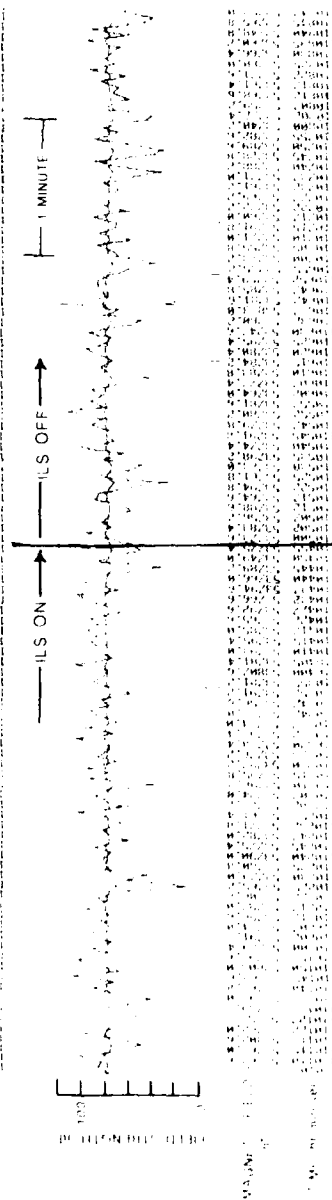
Figure 5. Magnetic field variations with time on the hardstand -- ILS on and off

11. Variations with time. Magnetic field versus time recordings for locations on and off the hardstand are shown in Figures 5 and 6, respectively. The top record in Figure 5 is for 9 April with the ILS operating normally. The remainder of the plots in Figures 5 and 6 are for 10 April and are approximately centered on the time of ILS on/off cycling. No detectable difference is noted between the ILS on and the ILS off conditions. There is, however, a notable difference between locations on and off the hardstand. For location 2, off the hardstand, the record is relatively smooth with 10 nT "spikes" superimposed on a low magnitude cyclical variation with period of 2-3 min; the spikes are likely due to thunderstorm activity in the area on 10 April. The record for location 1, on the hardstand, is extremely erratic and qualitatively appears random. Magnitudes of excursions from a baseline value vary somewhat for the plots in Figure 5 (30-80 nT), but the frequency contents are similar.

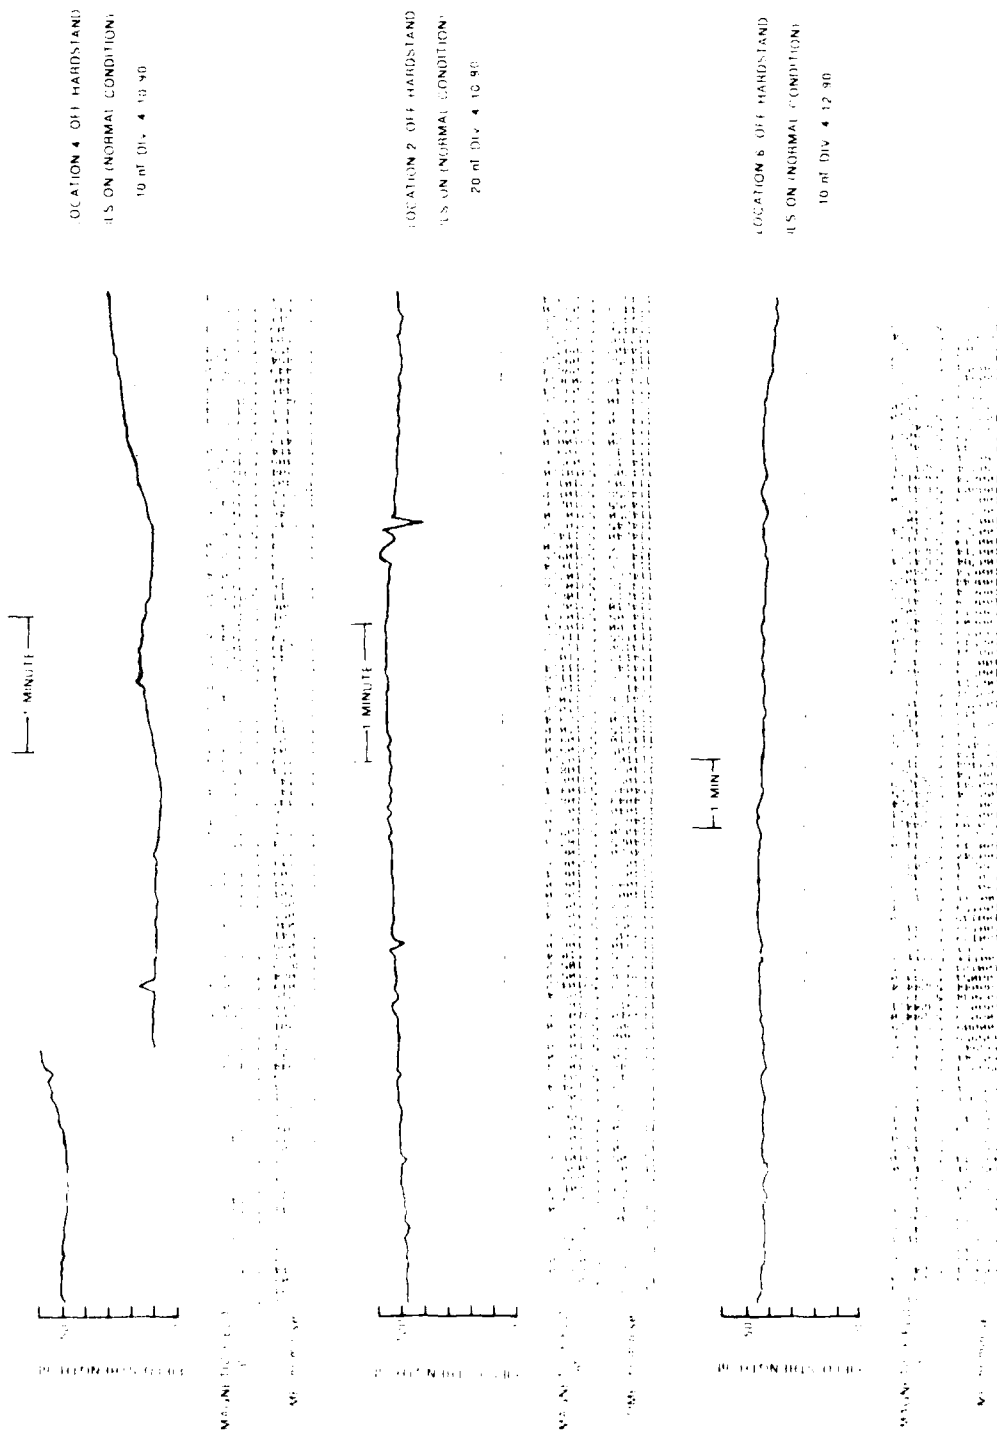
Figure 7. Magnetic field variations with time at three locations off the hardstand -- ILS on

12. Figure 7 contains three additional plots of magnetic field strength versus time for locations off the hardstand, all for 10 April and ILS on. These off-hardstand results are consistently different from the on-hardstand results shown in Figure 5. The record for location 6 on 12 April (bottom plot in Figure 7) exhibits no "spikes" (no thunderstorm activity on 9 or 12 April) and has a maximum variation from a baseline of less than 5 nT. Additional recordings of magnetic field strength variations at other locations on the hardstand (not shown) confirm the erratic characteristics shown in Figure 5 for location 1.

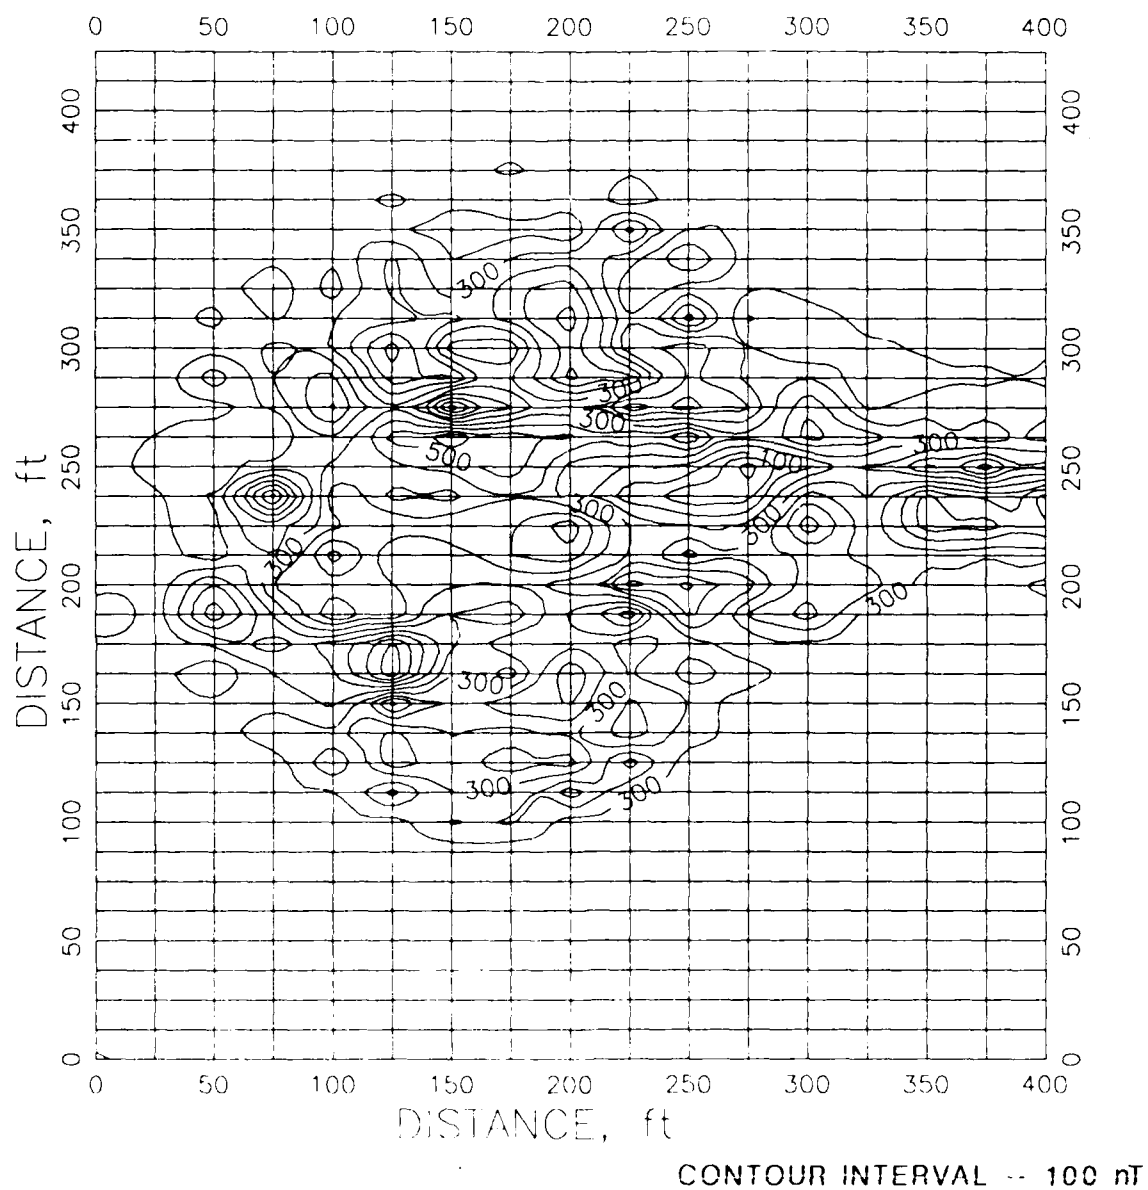
Figure 8. Magnetic anomaly contour map of hardstand area

13. Results of the magnetic survey over the grid area shown in Figure 1 are presented in Figure 8. Intersections of

the grid lines in Figure 8 are measurement points. The base station indicated in Figure 1 was reoccupied at approximately 30-min intervals, and the measurements were used to correct the survey data for time variations, relative to a reference field strength of 53,267 nT. The contour interval in Figure 8 is 100 nT and the maximum and minimum values are 686 and -328 nT, respectively. The extremely erratic nature of the field strength variations over the survey area results in a visually complicated contour plot. The complex nature shown by this contour map proves that the hardstand is highly anomalous; although, the surrounding area is magnetically "quiet." The magnetic contour map is in fact a map of the hardstand; the field varies so little over the area surrounding the hardstand that there are no contour lines off the hardstand.

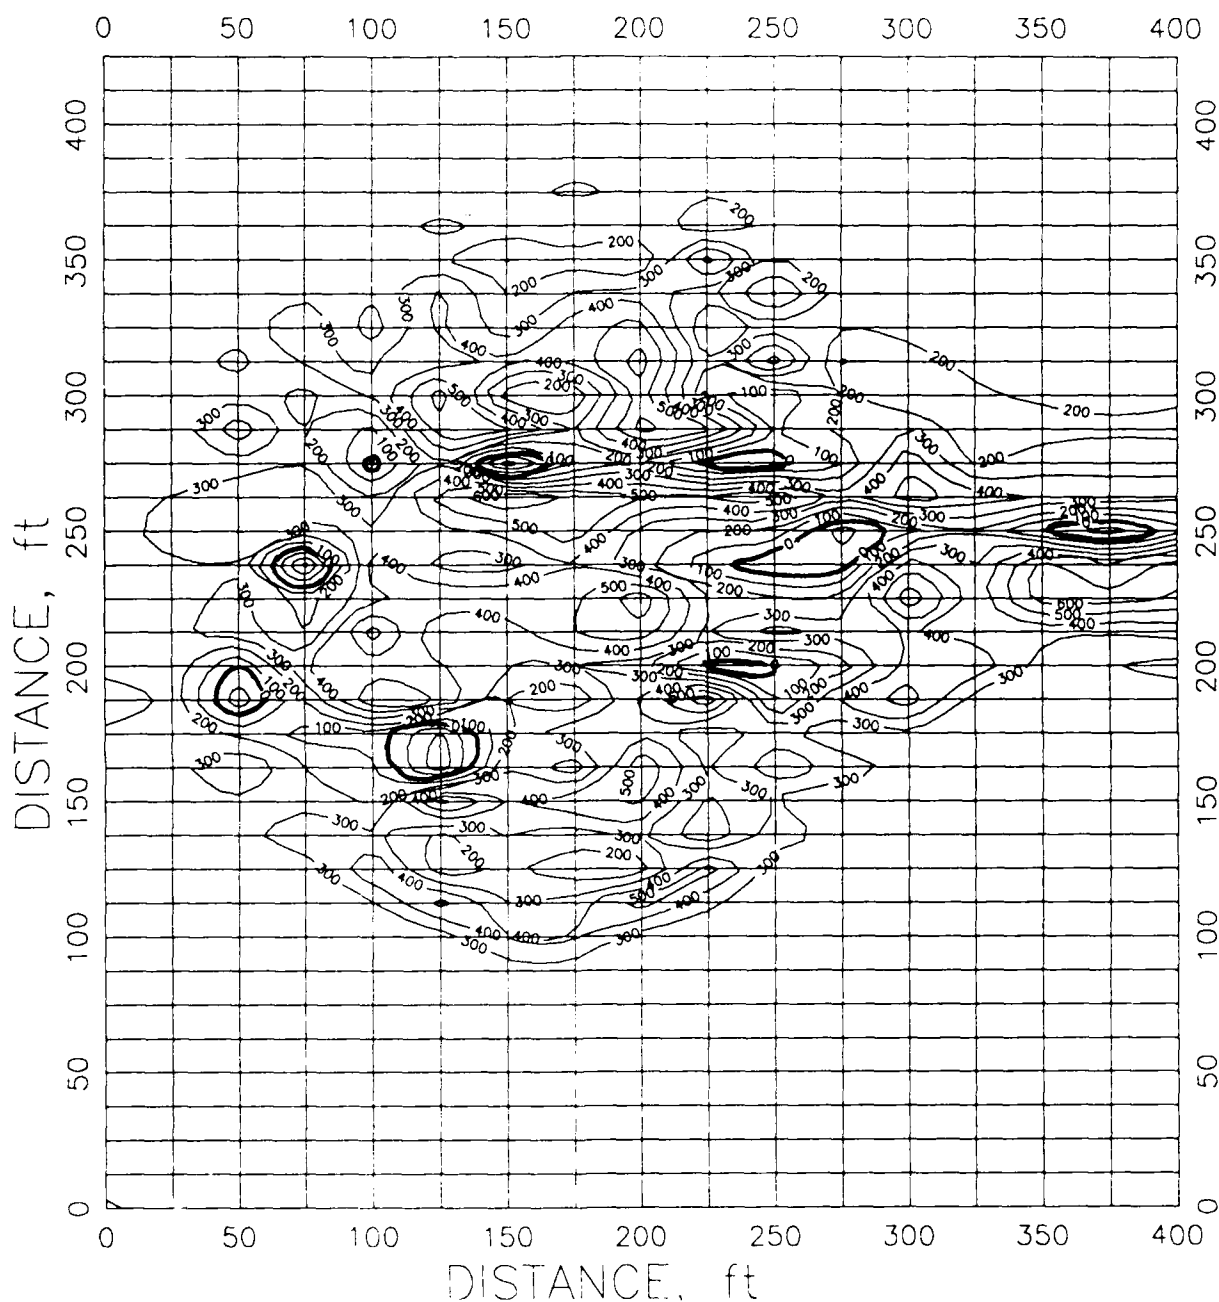
Figure 9. Magnetic anomaly contour map of hardstand area: different contouring parameters than used for Figure 8

14. Figure 9 is a plot of the data, produced with a different set of contouring parameters and with a bold zero contour, which illustrates that although the visual appearance of the map may change slightly the essential features are unchanged. There is no clear pattern to the magnetic anomalies on the hardstand. However, most of the low anomaly values are located around the periphery of the hardstand and in the approach to the hardstand, whereas the central region of the hardstand is predominantly a high anomaly area. A possible trend of low anomaly values extends from approximate locations (50,287.5) to (400,250). There is no readily apparent explanation for such a linear trend of low anomaly values. The only evidence of buried utilities in the area is a small, abandoned electric switch box at location (0,187.5), which is indicated by a small magnetic high anomaly. Base personnel maintain that the inactive line (conduit) to the switch box does not pass under the hardstand.

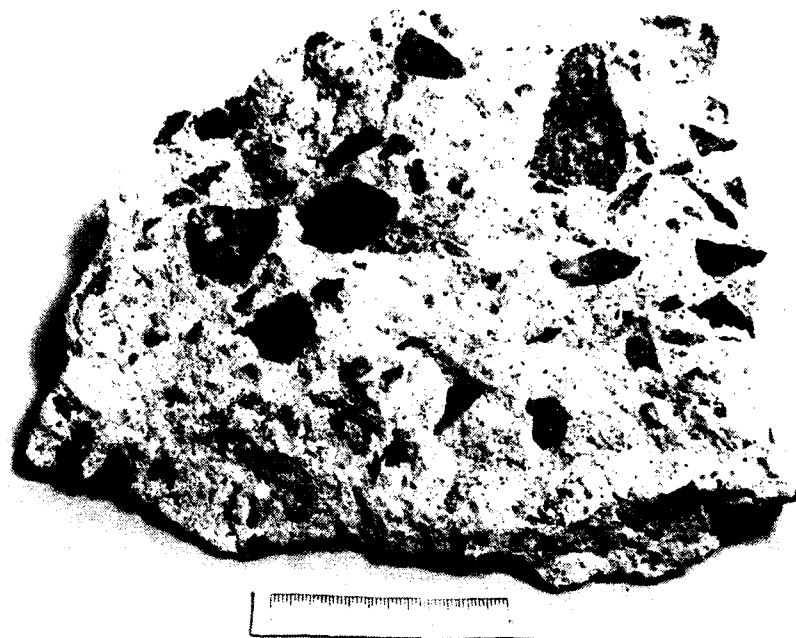
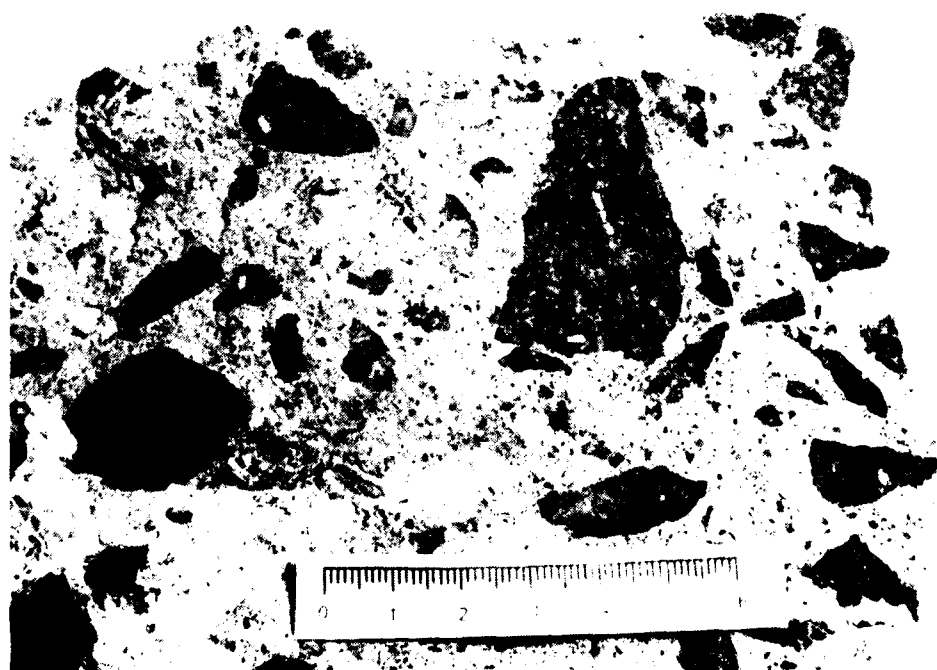
16. Examination of pieces of the hardstand concrete reveals that the aggregate is a dark, igneous material (Figure 10). The aggregate is from a well known local quarry, and is identified as nepheline syenite, which has magnetite as an accessory mineral. The permanent magnetization of the samples is sufficiently large to noticeably deflect a compass needle. The following tabulation lists the magnetic susceptibility of two concrete samples and one sample of shale from the Atoka Formation (local "bedrock") determined by the US Geological Survey, Branch of Geophysics, Denver, Colorado:

Figure 10. Concrete sample from calibration hardstand; aggregate is nepheline syenite, which has magnetite as an accessory mineral

Thus the bulk magnetic susceptibility of the hardstand concrete is 10 times the susceptibility of the shale "bedrock" and the susceptibility of the aggregate is 20 times that of the shale. Even the concrete matrix magnetic susceptibility is 2-3 times that of the shale. The magnetic aggregate in the concrete is the cause of the anomalous magnetic field on the hardstand. The aggregate has a permanent magnetization due to the presence of magnetite, and the permanent field component can have random strength and orientation due to variations in aggregate "density" throughout the hardstand.\* Also, the hardstand will tend to "amplify" time variations of field strength due to thunderstorm activity, nearby electromagnetic sources, and solar activity (flares, sunspots, etc.), due to the high bulk magnetic susceptibility.

- a. Remove the present hardstand and construct a new hardstand in the same location using nonmagnetic aggregate; a conservative amount of the hardstand approach should also be removed.
- b. Construct a new hardstand S-SE of the present hardstand location, using the present hardstand for access, and offset by several hundred feet.
- c. Construct a new hardstand at the alternate site indicated in Figure 11, offset by greater than 200 ft from the existing taxiway.

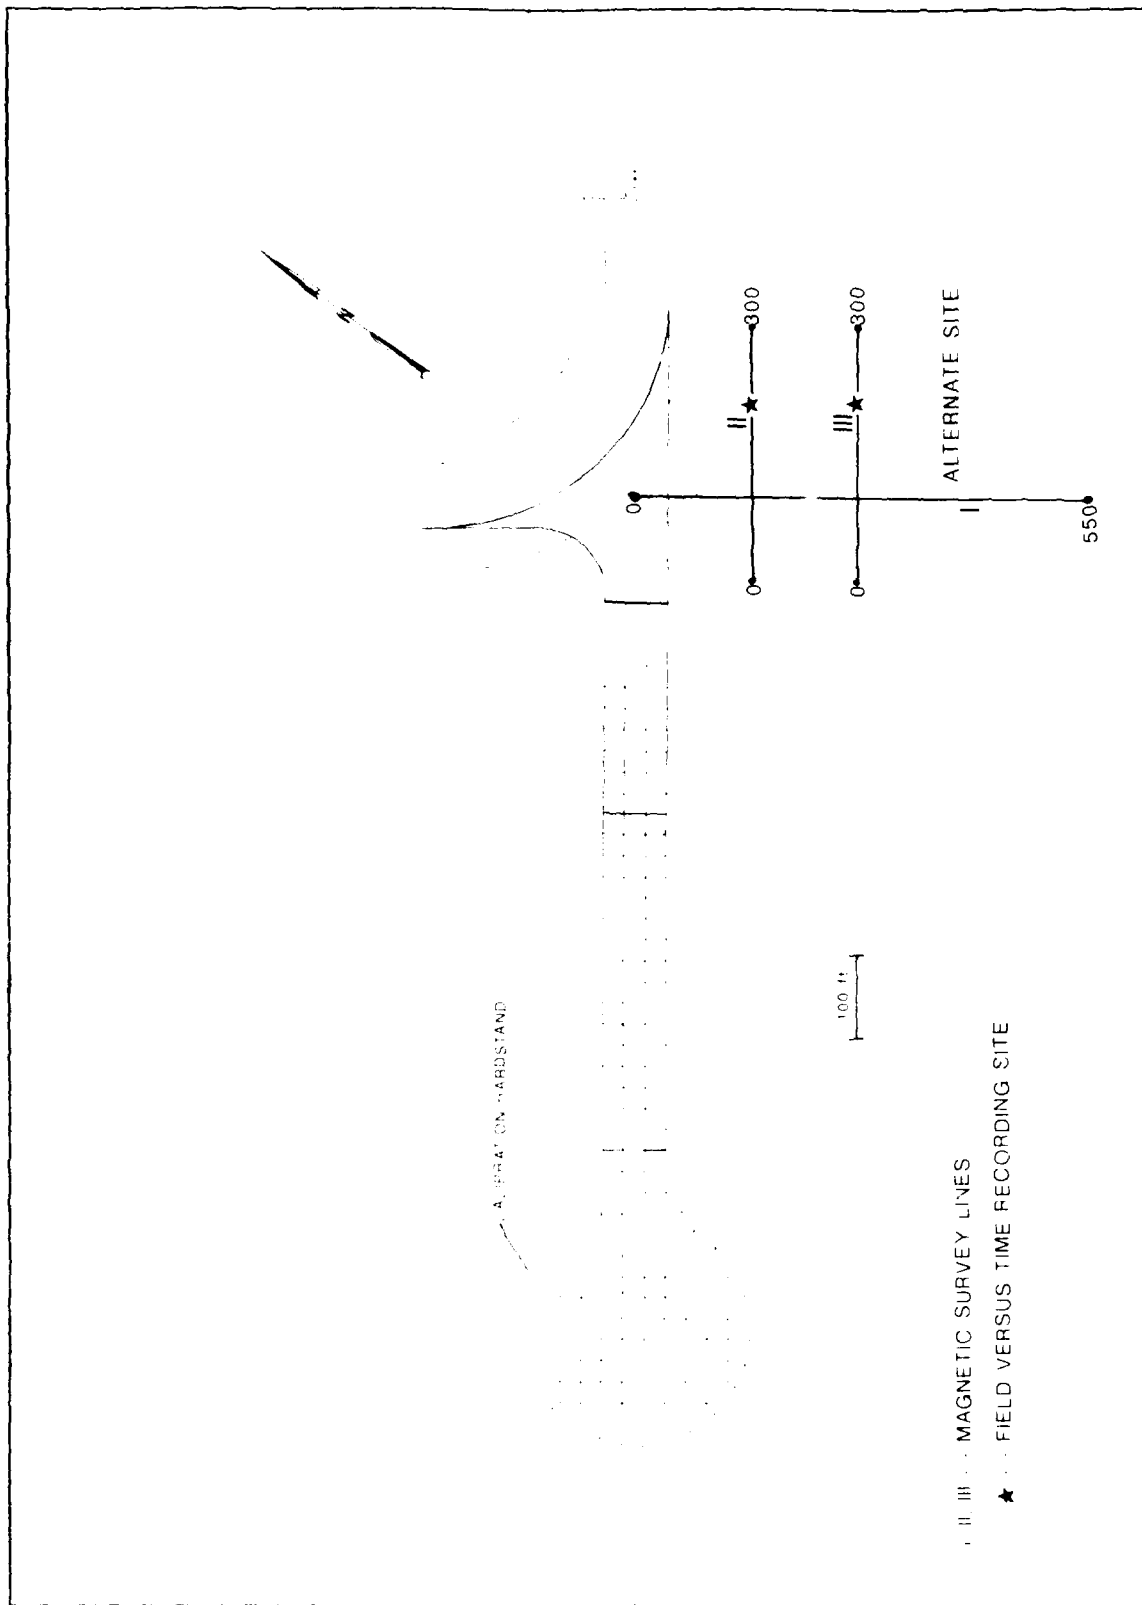
Figure 11. Survey line layout at possible alternate site for hardstand

20. The alternate site indicated in Figure 11 is apparently an acceptable site for a new hardstand. The closest point on a new hardstand to the existing taxiway should be in excess of 200 ft. Removing the hill to construct a new hardstand should not affect the constant magnetic field characteristic of the area since there is no topographic effect.

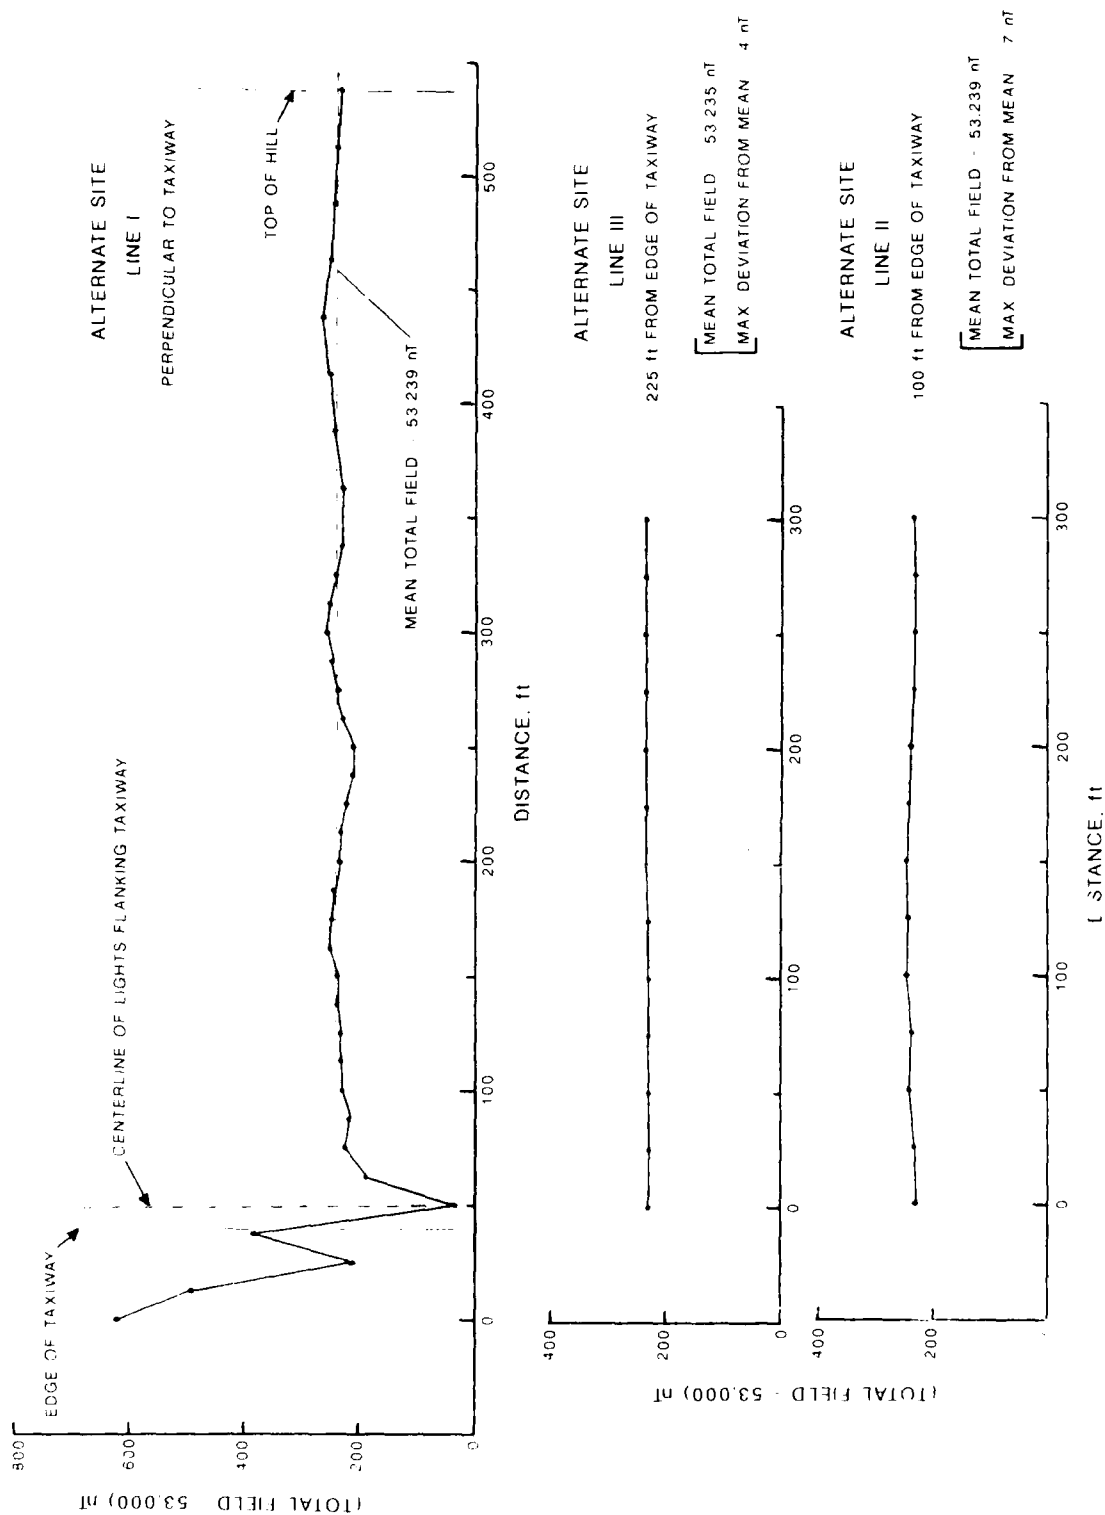
Figure 12. Magnetic field profiles along lines I-III at alternate site

18. The area S-SE of the present hardstand is already indicated as a possible alternate site for construction of a new compass calibration hardstand. Another area indicated by base personnel as a possible hardstand site is indicated in Figure 11, along with magnetic survey lines and recording sites. Results of magnetic surveys along lines I-III are shown in Figure 12. Line I begins in the center of a taxiway, and the magnetic field exhibits an erratic signature on the taxiway (consistent with the hardstand signature) but quickly assumes a nearly constant value off the taxiway. Line I ascends a hill beginning approximately at 260 ft\* (approximate el 230) and ends with the last measurement at the top of the hill (approximate el 340). There is no apparent topographic effect on the magnetic field. The magnetic field along the two offset lines (II and III), parallel to the taxiway, is virtually constant.

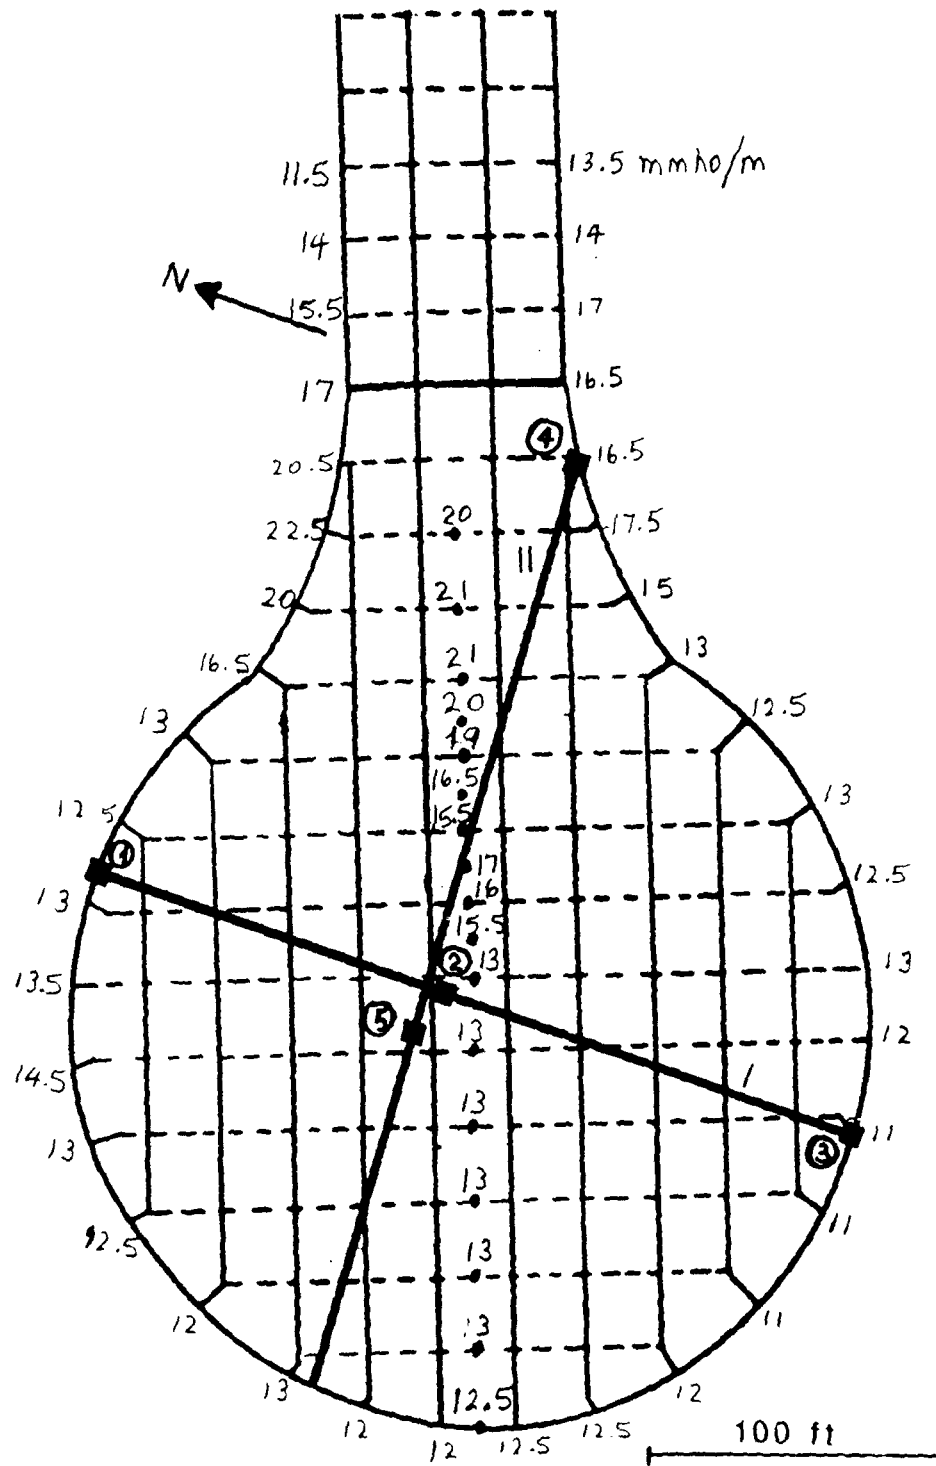
FIGURE 1. GEOPHYSICAL SURVEY LAYOUT AT THE CALIBRATION HARDSTAND

The locations of the geophysical measurements are shown in Figure 1. Lines I and II are N-S and E-W magnetic survey lines with measurements every 25 ft. The squares are locations where magnetic measurements were made as a function of height. The data were acquired with a proton precession (total field) magnetometer with an accuracy of 0.1 nT (nanotesla; the nominal earth's magnetic field strength at the air base is 53,000 nT). Results of the magnetic measurements are shown in Figures 2 and 3. The numbers around the periphery of the hardstand and along a line parallel to the center line of the access taxiway are conductivity values acquired with an electromagnetic conductivity device. The conductivity values represent an averaged conductivity of approximately the upper 20 ft of subsurface material. VLF EM measurements were made at the center of the hardstand and consisted of four scans of the frequency band in directions at 90-deg intervals.

A well-defined positive magnetic anomaly occurs with center at location 200 ft of line II (location of anomaly is indicated in Figure 1). The gradient at this location (5) is consistent with a positive anomaly caused by a subsurface source. Based on the width of the magnetic anomaly, the cause of the anomaly could be as deep as 75 ft.

A more comprehensive magnetic survey of the area over and around the calibration hardstand is recommended in order to better characterize the magnetic field variation. In conjunction with this survey, a recording magnetometer will be deployed to monitor for magnetic field variations at one location as a function of time. During the recording time, the nearby radar system should be cycled on and off at least twice; the off time would not have to be lengthy ( < 1 hr). During the on and off times, the magnetic field would also be repetitively surveyed along at least two orthogonal survey lines in addition to the continuous recording.
